Survival Factors

Airbag Safety Study Factual Report

Location: Boyceville, WI
Aircraft Type: Cirrus SR-22
Accident Date: August 5, 2006
Accident Time: 1140 CST
Accident Number: CHI06FA218
Airbag Equipped: Yes

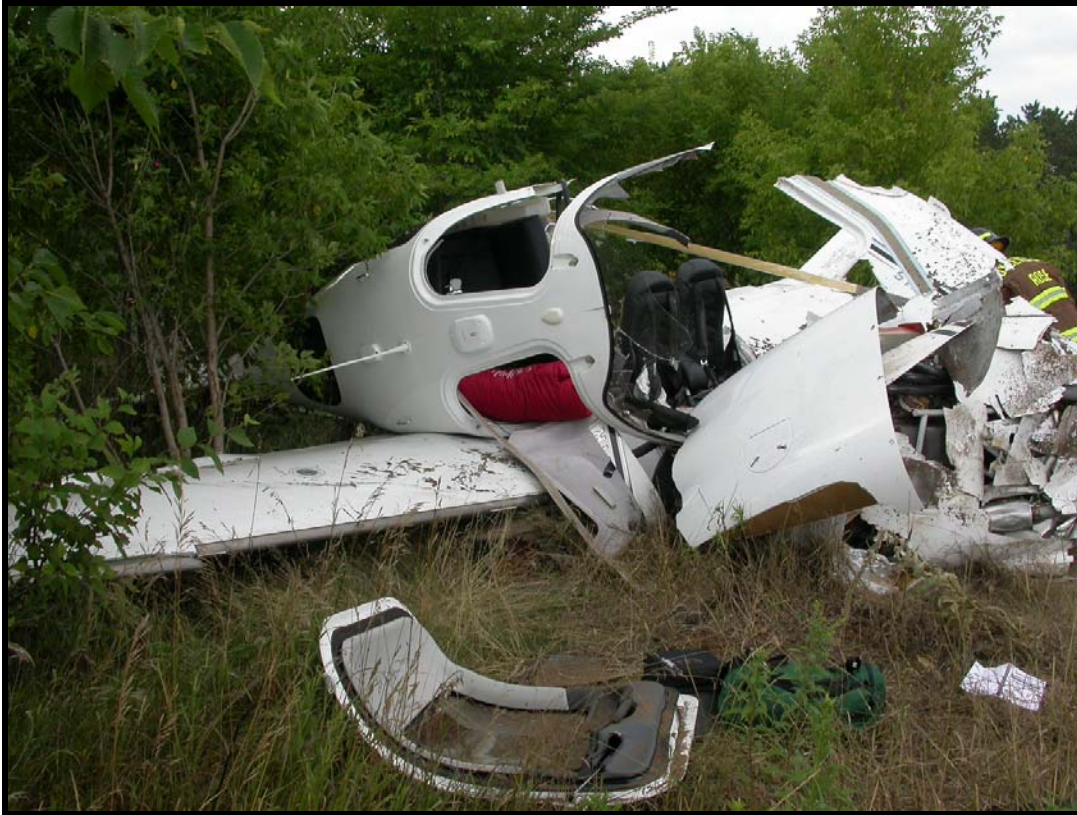
Figure 1: A photograph showing the damage to the aircraft. The two first row seats are visible in this photograph.

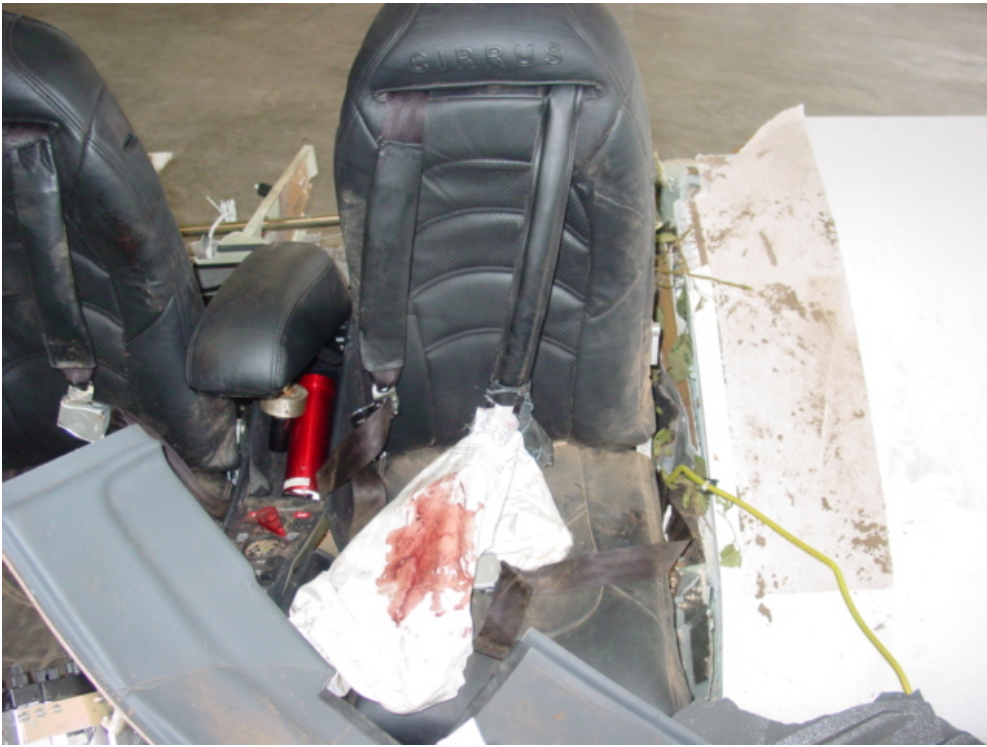
Figure 2. Left front seat

Both the left and right front seats were attached to the spar tunnel. The left front seat is shown in figure 2. The aft, outboard seat slider was found approximately 4.25" from the aft end of the seat rail. The inboard slider was found approximately 3.875" from the aft end of the inboard seat rail. The left front energy absorption module (EAM), which has a nominal thickness of 3.5", exhibited crushing damage across its leading edge from its left and right corners. The crushing extended across the top, from front to rear, approximately 2.0" aft from the left front corner and right front corner and approximately 6.0" aft across the middle. The left front energy absorption module's leading edge was approximately 2.75" thick. The following information was written on the EAM: 102105, 001121-3, 14152-004, 10-21-05.

The left front seat airbag, shown in figure 2, had an approximately 4-6" in diameter blood spot on the occupant side of the bag. There was a smaller spot on the instrument side of the bag that matched the position of the larger spot and may have resulted from blood soaking through the airbag. There were no other marks or scuffs on the airbag. The upper vent hole was slightly frayed at its top (1200 position) and the lower vent hole exhibited stress but no fraying was documented.

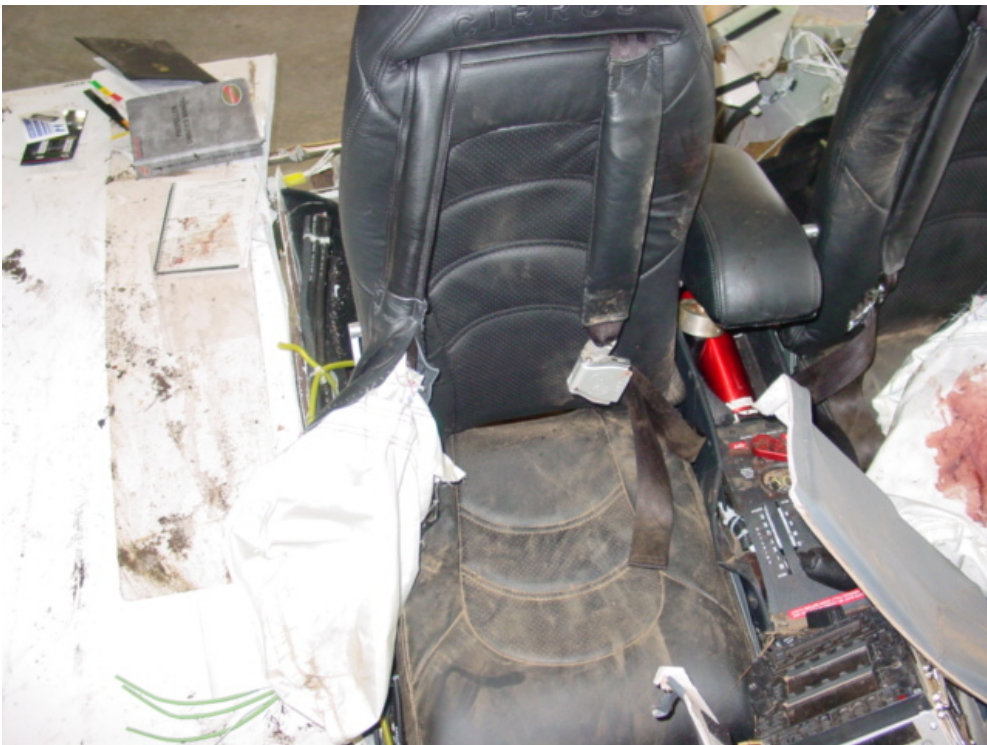
Figure 3. Right front seat.

The right front seat is shown in figure 3. The inboard and outboard seat rail sliders were found 6.5" forward of the aft end of the seat rails. The right front EAM exhibited crushing damage across its leading edge from its left to right corner. The crushing extended across the top from front to rear approximately 3.0" aft from the left front corner to approximately 6.0" aft from the right front corner. The right front energy

absorption module's leading edge was measured to be approximately 2.75” thick. There was also a minor indentation/impression in the location of the seventh (from rear) adjustment hole of the outboard seat rail. There was a corresponding shallow indentation in the thin aluminum seatpan above the EAM. The following information was written on the EAM: 102105, 001114, 14152-004, 10-21-05
